Physical and structural obstacles for post-mortem computed tomography quality

Introduction

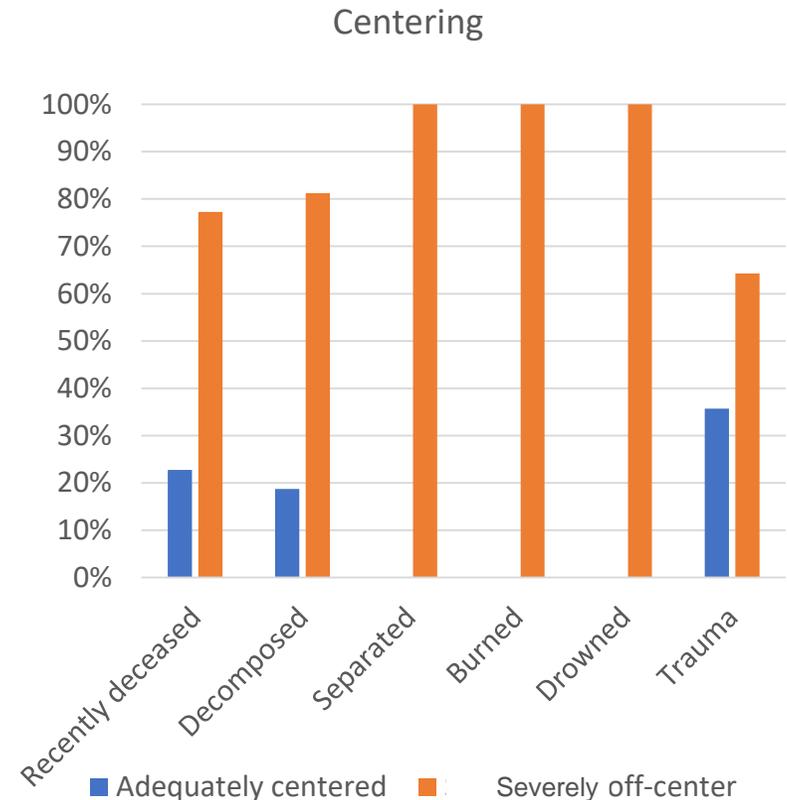
Table 1.
 Ratio of deceased that are adequately centered, or severely off-center, categorized on status of the deceased

- The deceased was off-center in 77% of the scans
- Off-centering was correlated with the condition of the deceased at the time of scanning
- Weight status also correlate with centering. One hundred percent of underweight, 76% of normal weight and 70% of the overweight deceased were off-center

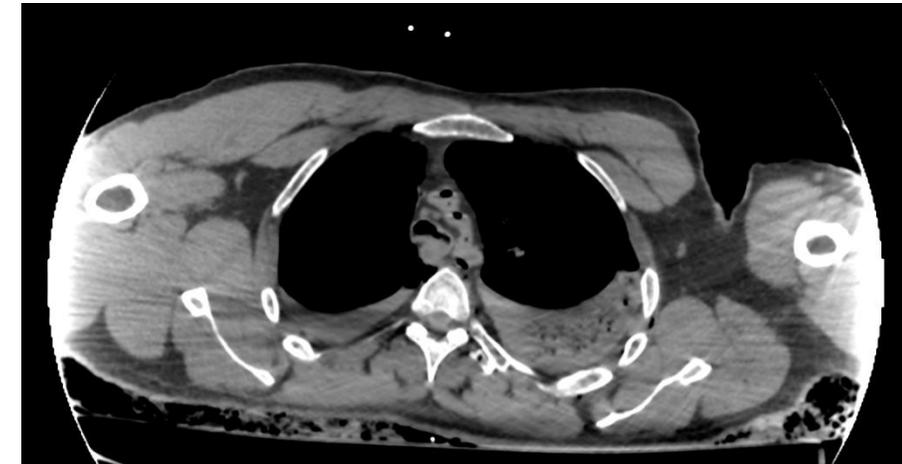
Figure 1. Example of scan with anatomy outside scan field of view. Besides missing information, the incomplete projection also results in streak artifacts, causing sub-optimal imaging of the thoracic cavity

- One hundred percent of scans had some anatomy out of Field Of View, resulting in out of field of view artefacts. Missing anatomy was predominantly vertex and elbows
- Part of the anatomy was also missing in the truncal area; thorax area was affected in 21%, abdomen in 19% and pelvis 26% of scans
- In 53% of the scans, the head was not centered correctly
- Arms were placed next to, or on the trunk, and often asymmetrically

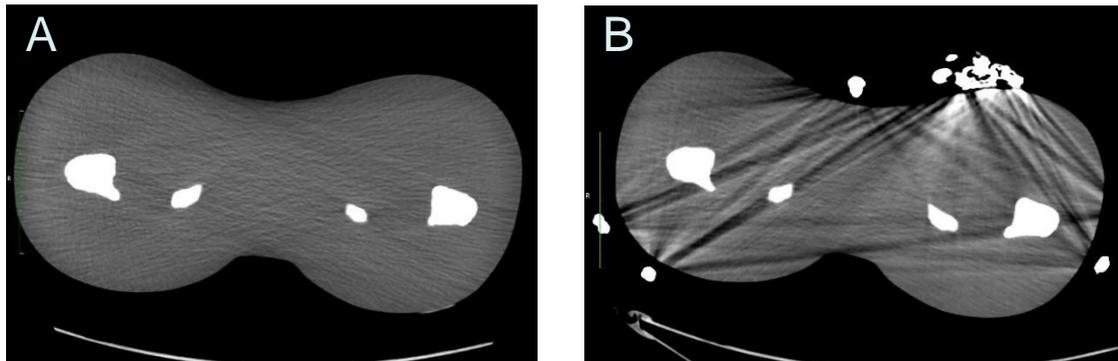
Figure 3. External metal in the pelvic area.

A represents deceased where no metal is present.

B represents deceased with metal objects present; keys, zipper, buttons and studs.

∴ The metal interacts, even over large distances, and causes streak artifacts and shadows that can mask anatomy

- More than 90% of the scans had metal artifacts that affected the imaging
- Metal objects were found both internally and externally of the deceased
- Loose metal (keys, coins, phones), were often placed on top of the body, or next to the head

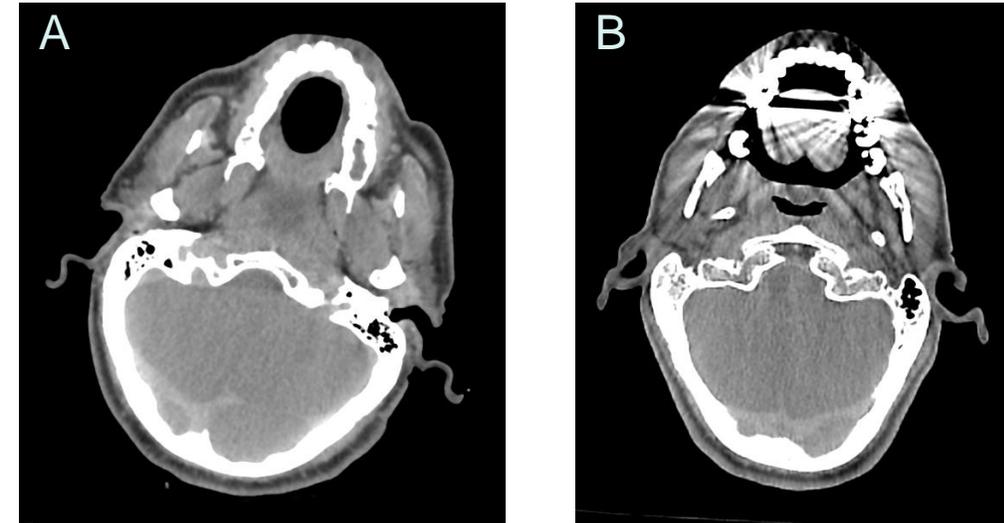
Figure 2. Metal artefacts from dental implants. A represents deceased without dental implants. B represents deceased with dental implants. Notice how metal interacts and cause streak artifacts in the scan.
